The Use of Unmanned Aerial Vehicles for Sloped Roof Inspections – Considerations and Constraints

Abstract

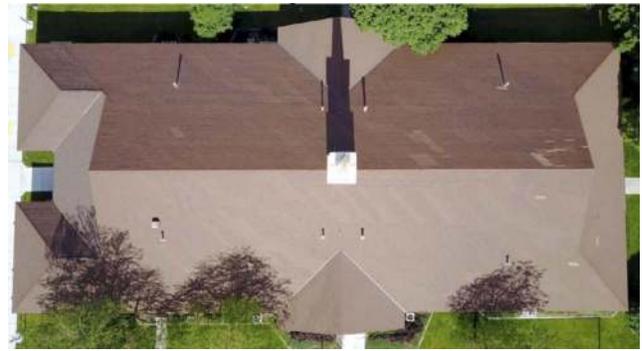
ILLUSTRATION 4.—Initial Image at 180 Feet to See Defect Zones

was found that if the entire roof was pictured at the 10-15 foot level, it was hard to keep track of which part of the roof was being shown. It is possible to get a good overview of the general condition of the roof by zooming in on the quadrant-height images, supplemented by the detail-height images. The vertical still image approach is the preferred method. It is the most efficient method to manage, and can be expanded to give more detail by dividing the roof into more sections if the quadrant height is reduced from 70 feet. Examples of image quality using this approach can be seen in Illustrations 4 and 5.
